Manhole Inspection Summary

Manhole # S27M__025MH

Location Address: **1173 W Ostend St** Cross Street: **Washington Bd**

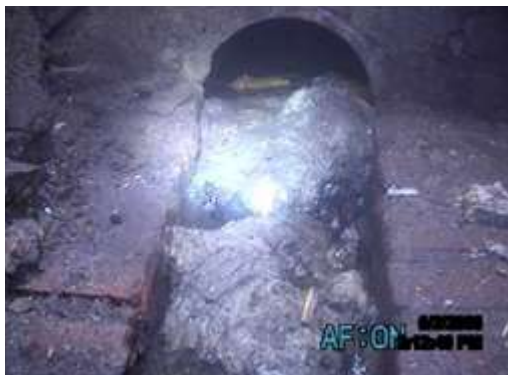
Defect 1

Condition: ☐ Sound ☐ Cracked ☐ Root Intrusion ☐ Deteriorated ☐ Leaks ☒ **Debris**

debris in channel at 9 oclk

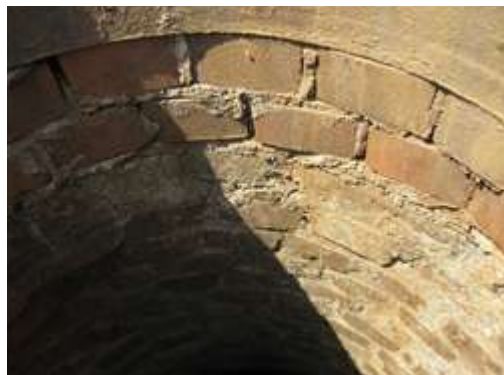
Defect 4

Frame Offset: **0** (in.) Condition: ☐ Sound ☐ Cracked ☒ **Leaks**

Infiltration: ☐ None ☐ Joint ☐ Cracks ☒ **Mortar** ☐ Roots ☐ Wall

missing mortar; signs of infiltration coming from lid - frame connect

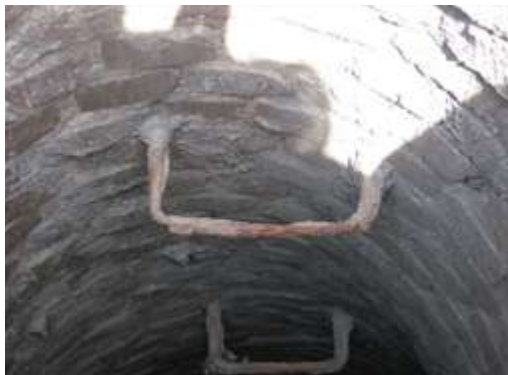
Defect 3

Steps Count: **4** Missing: **1** ☒ **Corroded**

missing/corroded steps

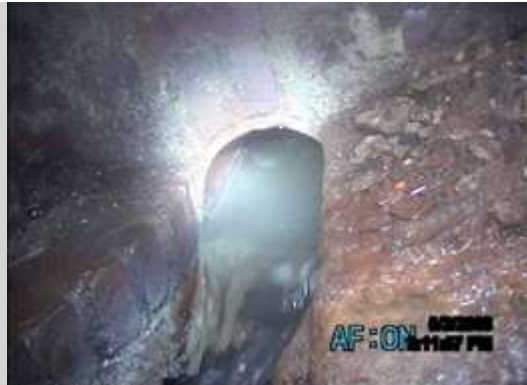
6 O'Clock Inflow

Deposits: ☐ None ☐ Mud ☒ **Sludge** ☐ **Debris** ☐ Grease

Silt Depth: 3 (in.) Deposits Extent: **Medium**

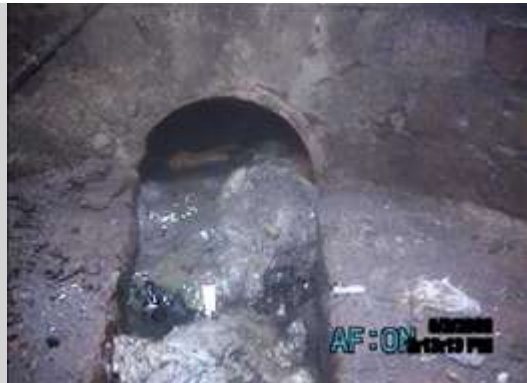
9 O'Clock Inflow

debris in channel

Deposits: ☐ None ☐ Mud ☒ **Sludge** ☒ **Debris** ☐ Grease

Silt Depth: 4 (in.) Deposits Extent: **Heavy**
